Martha G. VanGeem¹, Kami Farahmandpour¹, and John Gajda¹

CASE HISTORIES OF BUILDING MATERIAL PROBLEMS CAUSED BY CONDENSATION AT AN ENCLOSED SWIMMING POOL AND AN ENCLOSED ICE RINK

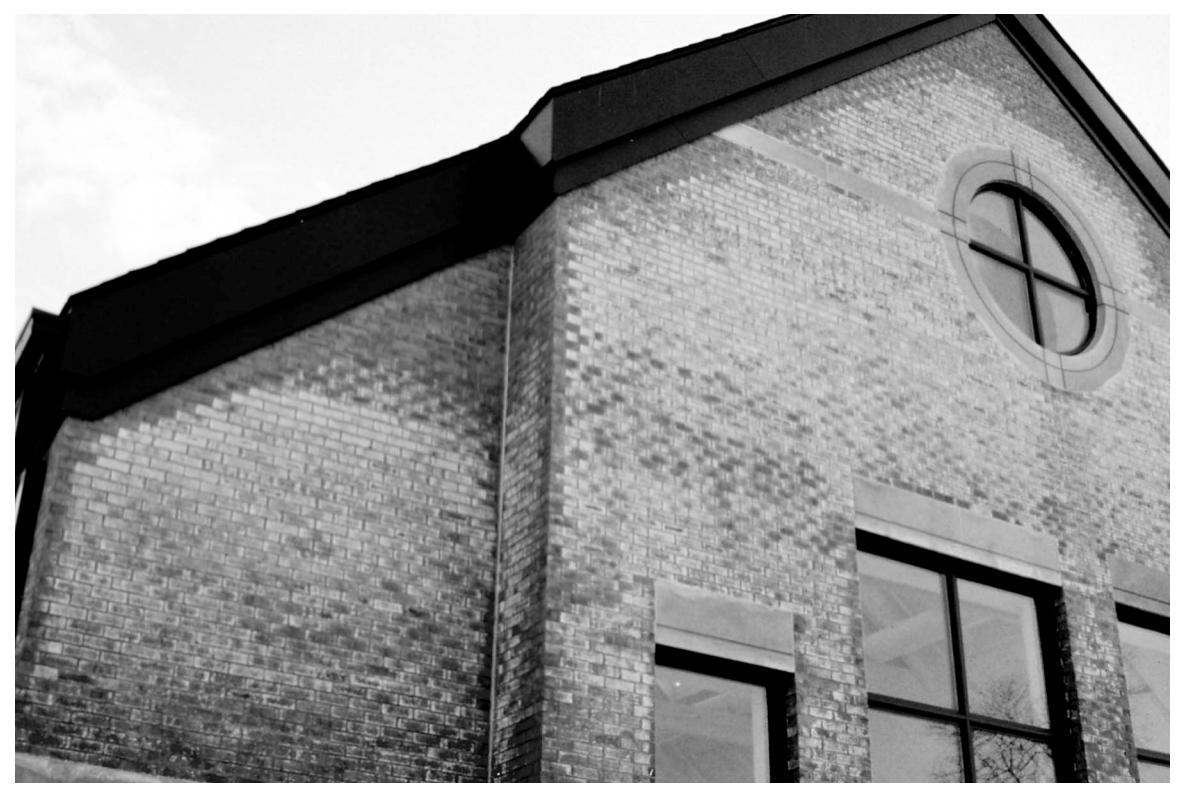
Figure 1 – Area of Severe Efflorescence on the Exterior of the Pool Area

Severe efflorescence was observed on exterior masonry surfaces at the north wall (Figure 1). Efflorescence was also observed on the east and west walls of the pool area as well as the fireplace chimney on the east elevation. The fireplace was located in a lounge area adjacent to the pool area.

The efflorescence observed on the exterior masonry was also attributed to lack of an effective vapor retarder. In absence of an effective vapor retarder, warm, humid air from the pool area penetrated the porous plaster finishes, CMU, and rigid insulation. As it reached the colder surfaces of the exterior brick it condensed. This condensed moisture was continuously driven towards the outside by higher water vapor pressure on the inside. As it passed through the porous mortar, it dissolved water-soluble salts such as calcium carbonate and brought these salts to the outside surfaces of the brick. Eventual evaporation of the moisture left these salts on the masonry surface in form of the observed efflorescence.

Recommendations were to provide a continuous vapor retarder in the exterior wall assemblies by installing a vapor retarder over the existing interior surfaces. A layer of moisture-resistant wallboard (such as cement board or cement plaster) was recommended over the vapor retarder. It was also recommended that the interior surfaces of the wallboard be finished and painted with a vapor retarding paint.

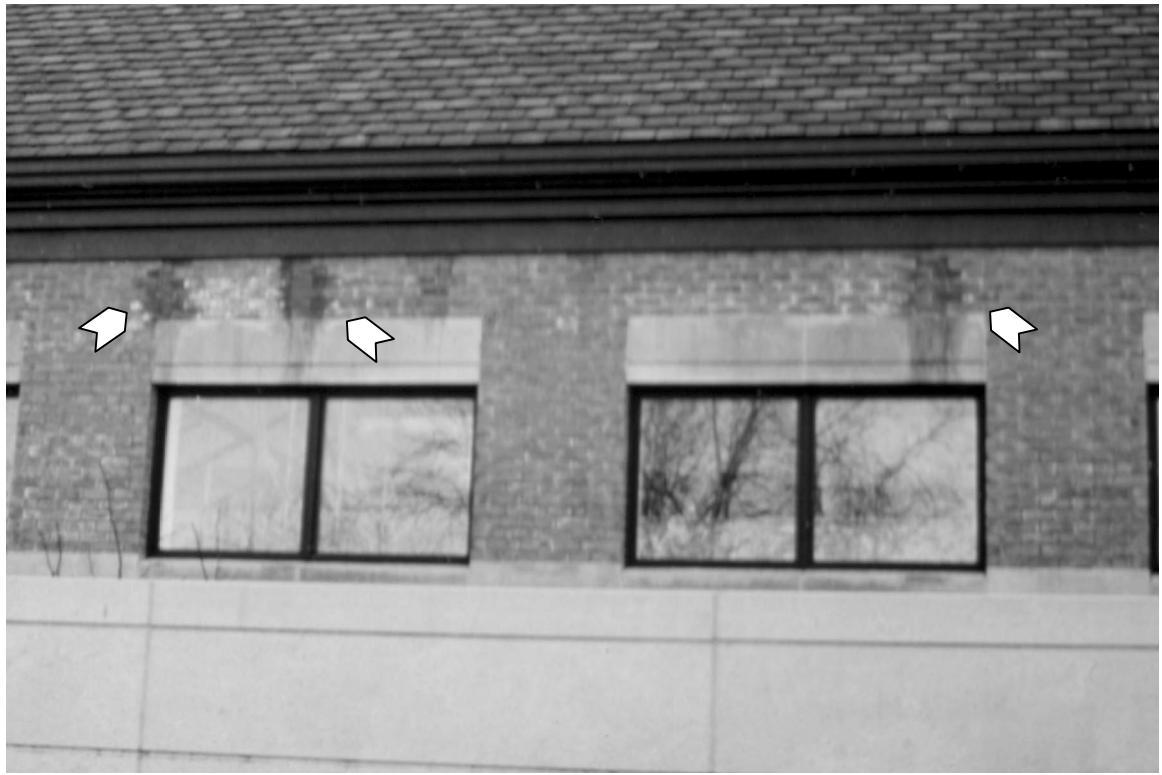
Figure 2 – Water Staining below Eaves on the Exterior of the Pool Area

Visual review of the building exterior confirmed presence of several brown stains on the brick masonry immediately below the pool area roof eaves (Figure 2). These stains were not limited to the areas below the skylights and appeared uniformly distributed. It appears that the staining was caused by condensed water that formed on the outside surfaces of the ventilated deck boards. This condensed water would dissolve brown, water-soluble compounds within the OSB and would flow down the roof deck, discharging at the eaves.

In general, the reported leaks at the skylights in the pool area were attributed to condensation in the roof assembly. The brown stains at the exterior walls were also attributed to this condensation. As water condensed in the roof assembly, it leaked to the interior at the skylight openings, or ran down over the surfaces of the OSB and discharged at the eaves.

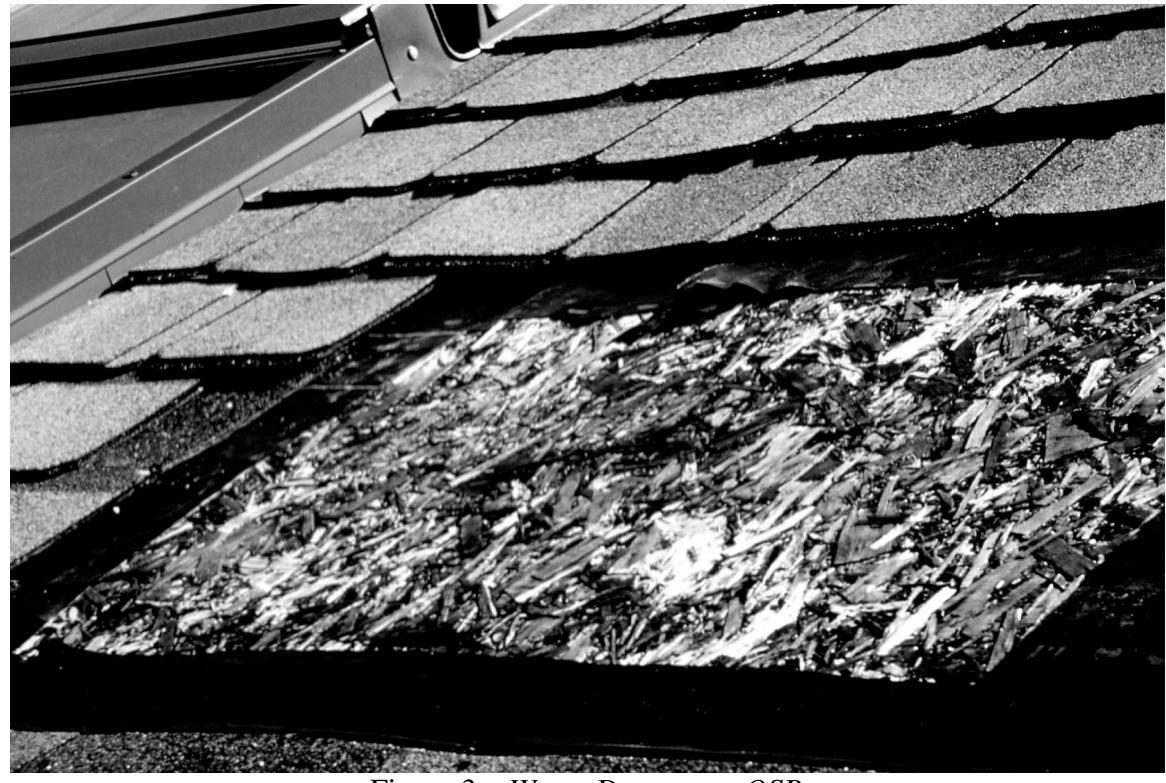
Observations within exploratory openings into the exterior roof surface revealed water damage to the OSB boards in all cases (Figure 3). The water damage was accompanied with mildew in areas adjacent to the skylight. This condition was attributed to presence of the ice and water protection membrane placed over the outer OSB board in those areas. The presence of this relatively impermeable layer slowed evaporation of the condensate from the OSB boards and promoted mildew growth. In all exposed areas, the damage caused by the condensation was severe enough to adversely affect the physical characteristics of the OSB boards.

Figure 3 – Water Damage to OSB

The condensation in the roof assembly was caused by lack of an effective vapor retarder on the interior surfaces of the roof assembly. Condensation caused damage to the ventilated deck boards and other roof assembly components.

Recommendations for installing a vapor retarder in the roof assembly were to remove all components down to the tongue and groove wood deck, and to rebuild them. The new roof assembly was designed to contain a ventilated air gap between the top of existing tongue and groove decking and a new vapor retarder. Adequate insulation, nailer boards, and roofing materials were specified over the vapor retarder.
